August 19, 2022

**Re: Town of Greenwich
Probable Construction Cost Estimate – Accessibility Upgrades
LaBella Project No 2223079**

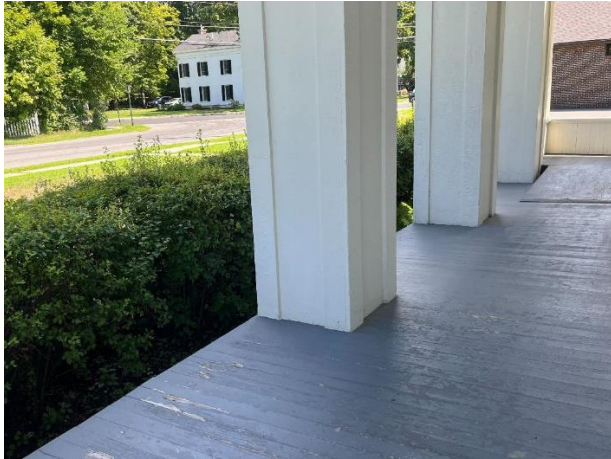
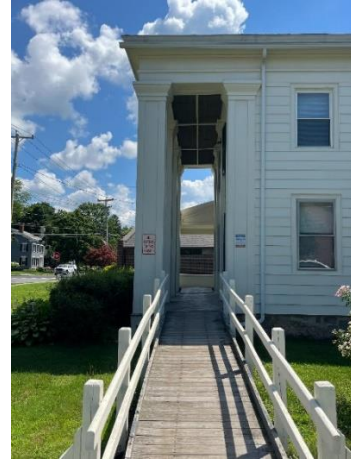
4.1.11 Entrance with Ramp and Stairs

- Limited topographic survey needed to confirm grade and elevations.
- Unsafe condition of existing handrail should be repaired/replaced in accordance with the *Property Maintenance Code of New York State*:
PMC 304.1.1 Unsafe conditions. The following conditions shall be determined as unsafe and shall be repaired or replaced to comply with the Building Code of New York State or the Existing Building Code of New York State as required for existing buildings:

- The existing 2x4 ramp handrails are not continuous and should be replaced.
EBC 805.9.2 Design. Handrails required in accordance with Section 805.9.1 shall be designed and installed in accordance with the provisions of the Building Code of New York State.
BC 1014.4 Continuity. Handrail gripping surfaces shall be continuous, without interruption by newel posts or other obstructions

- Existing porch has three risers and is required to be provided with handrails.

New Handicap Access Ramp - \$32,800.00

- Concrete (4000 psi)
- Railing both sides

Refinish Wood Ramp (Alternate if Compliant) - \$1,325.00

- Prepare surface
- Prime & paint 1 coat, roller & brush

- Repair 2x4 bottom rail

Porch Railing -

\$2,560.00

- Architectural grade, hardwood, plain
- Prime & paint 1 coat, roller & brush

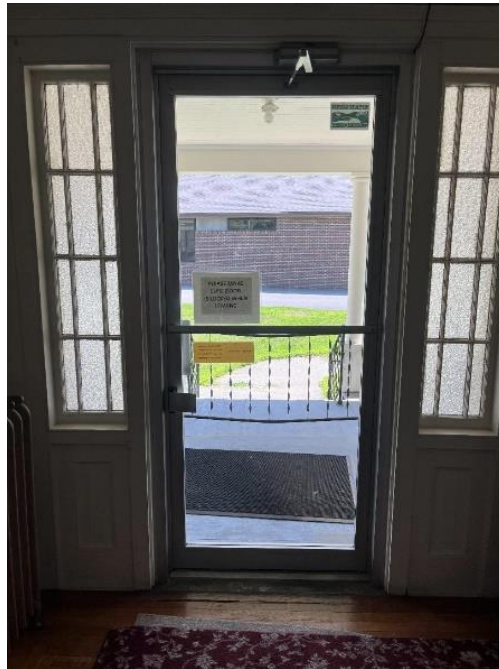
4.1.11.4 Entrance door is difficult / heavy to operate. Doors shall have a maximum of 5 lbs opening force. 2009 ANSI 117.1 404.2.8. Recommend installing an automatic door opener.

- The existing push pad does not comply with the requirements for panic hardware.

- Access control system can be added, which would include provisions for a key fob, however, this is typically not practical with a single opening and would require computer for maintenance of badging system (fobs) and annual licensing contract for system.
- Low-energy power-operated door opener could be added assuming there is adequate approach to the door and landing for activation mechanism.
- An accessible entrance must remain unlocked while the building is occupied; or, a locked accessible entrance with a notification system or remote monitoring shall be provided.

Automatic Opener Door Hardware -

\$9,885.00

- Electronic door opener including motion sensor, 12V control box, motor
- Single swing door opening
- (2) handicap actuator buttons, including 12 V DC wiring
- Electric panic button per door.

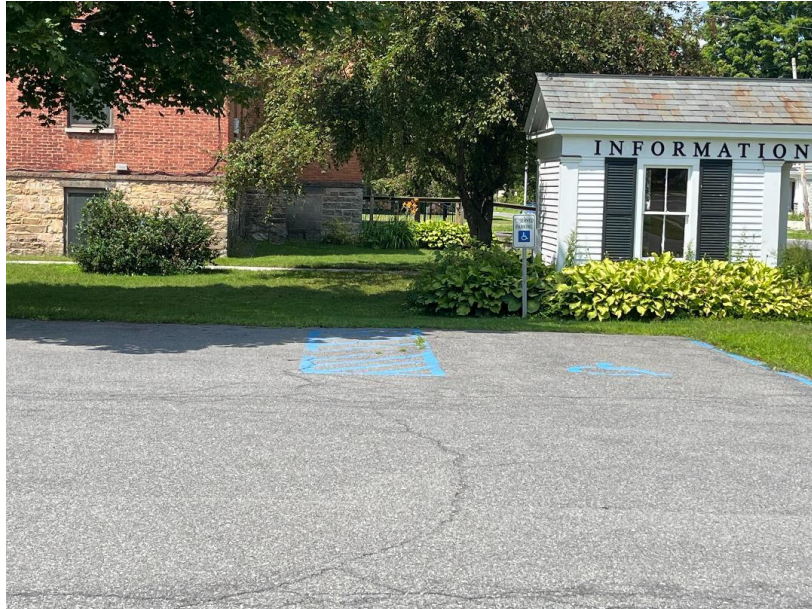
4.1.14 Accessible Parking

- The asphalt pavement surfaces appear to be in fair condition. The new striping should be performed as part of overall pavement management plan to seal existing parking lot, at which time any cracks should be sealed.

Parking Lot Repair and Sealcoating -

\$780/M.S.F.

- Thoroughly clean surfaces
- Patch miscellaneous holes
- Fill cracks
- Install 2-coat petroleum resistant emulsion
- Restripe lot/Lines on pavement parking stall, 4" wide
- Accessible Parking Signage

\$90/stall
\$1,800.00
